# Print Quality Trouble Shooting Guide

## V-Series

Version 1.0

Date: 2/18/2025

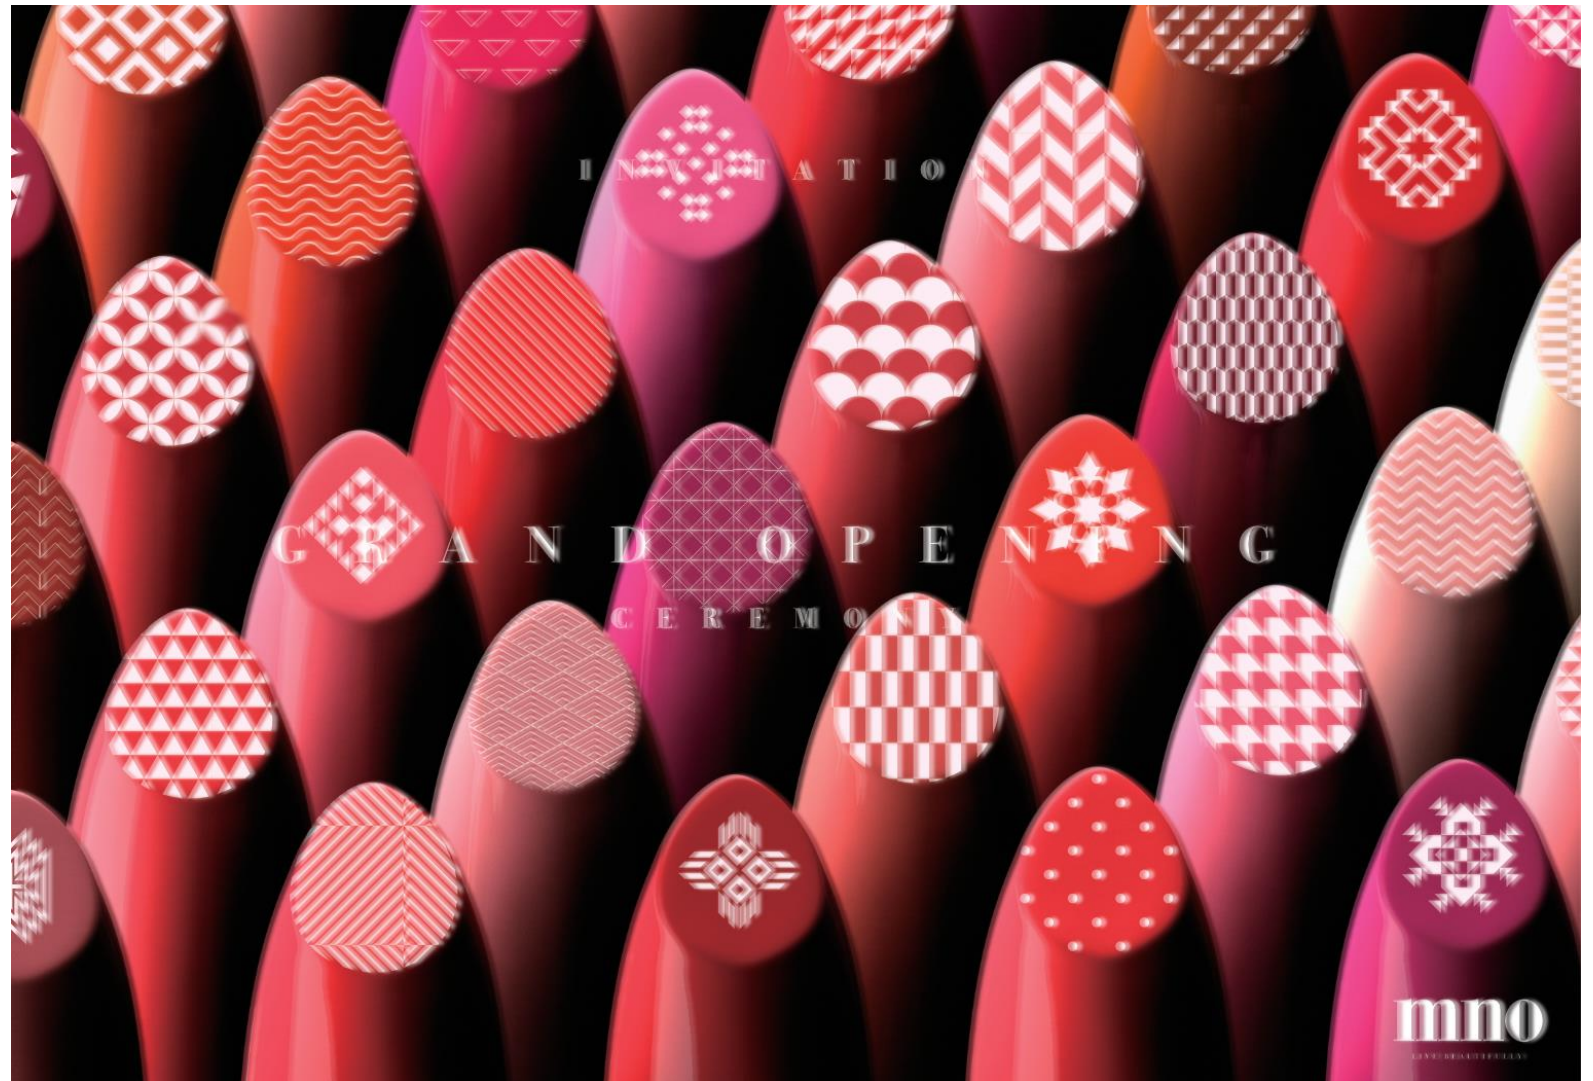
### Causes

- Head set too high
- Low quality images
- Poor quality media/absorbent media
  - EG: Styrofoam, Cardboard, Wood (Soft/Porous), Fabric
- If print is wet may be curing issues

### Effect: Print is blurry across entire job

### Solutions

- Ensure proper head height
- Use a higher quality image
- Increase white base layers or use higher quality/alternative media
- If wet: see section on wet/curing issue

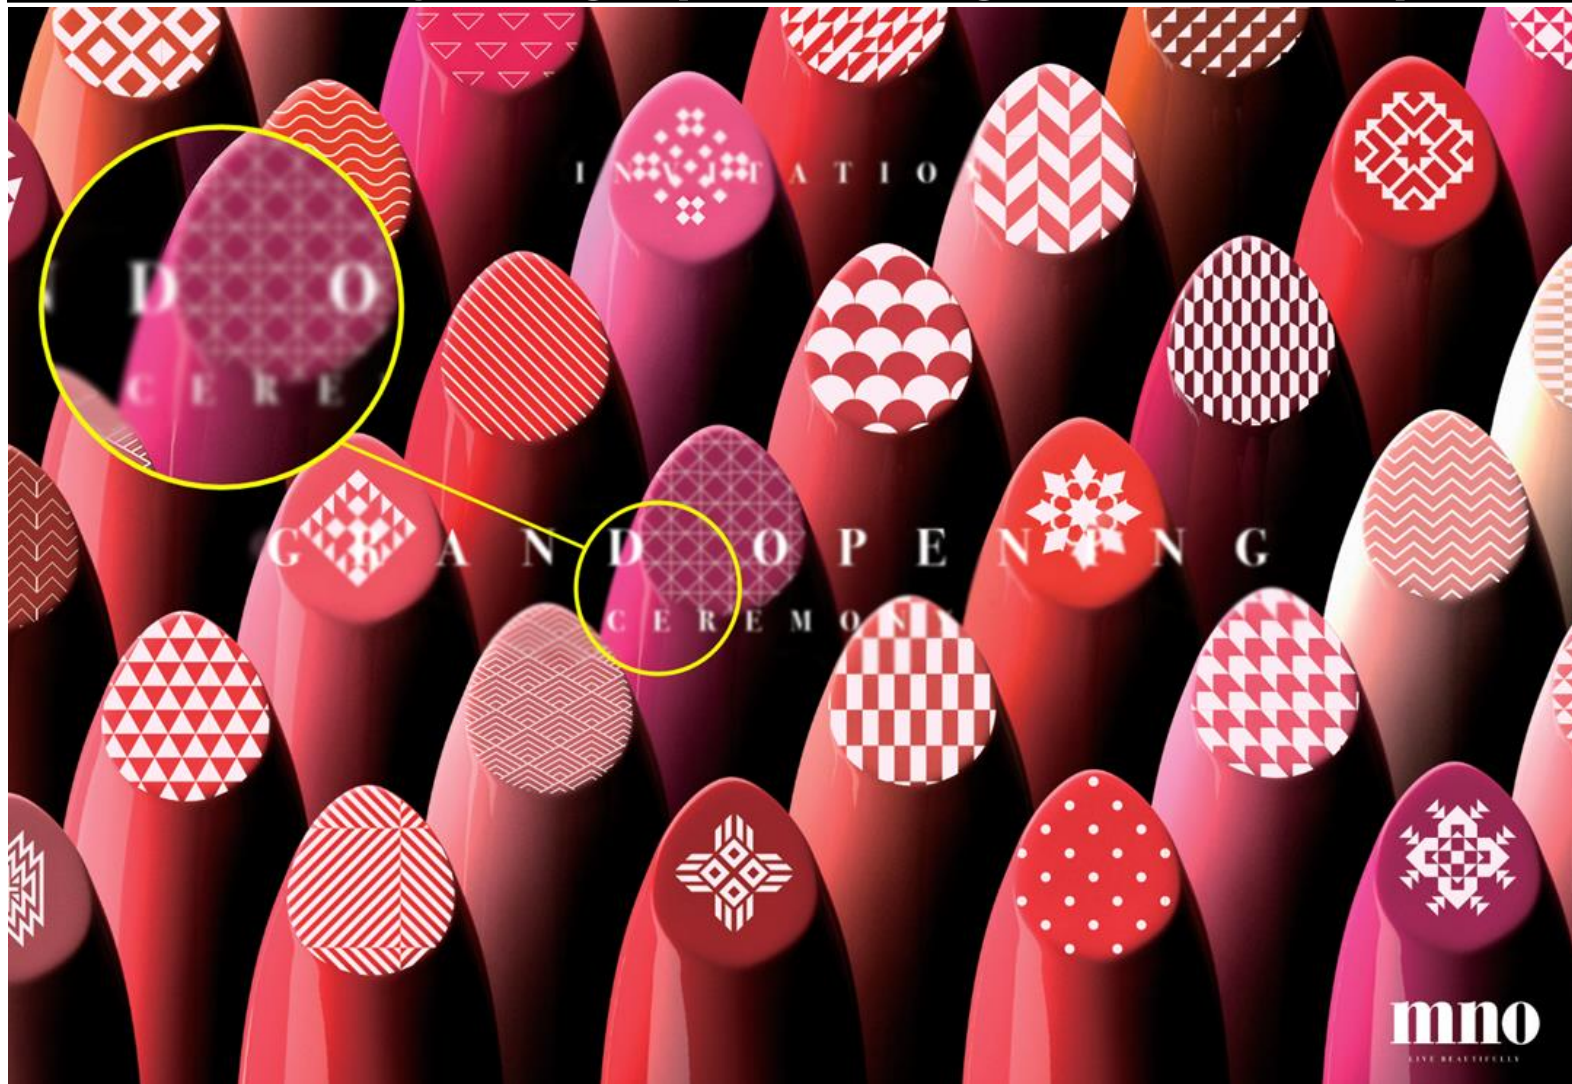
## Blurry (Left to Right/Text)

### Causes

- Head misalignment (bidirectional)
- Platen gap too high
- If confined to a corner, could be an unlevel bed

## Effect: Blurry Image (Left to Right/Horizontal)

### Solutions

- Run head alignments/bi-directional adjustment and head alignment.
- Print unidirectionally
- Platen gap. Measure media and set manually.
- Fine text print mode for white.
- Level bed

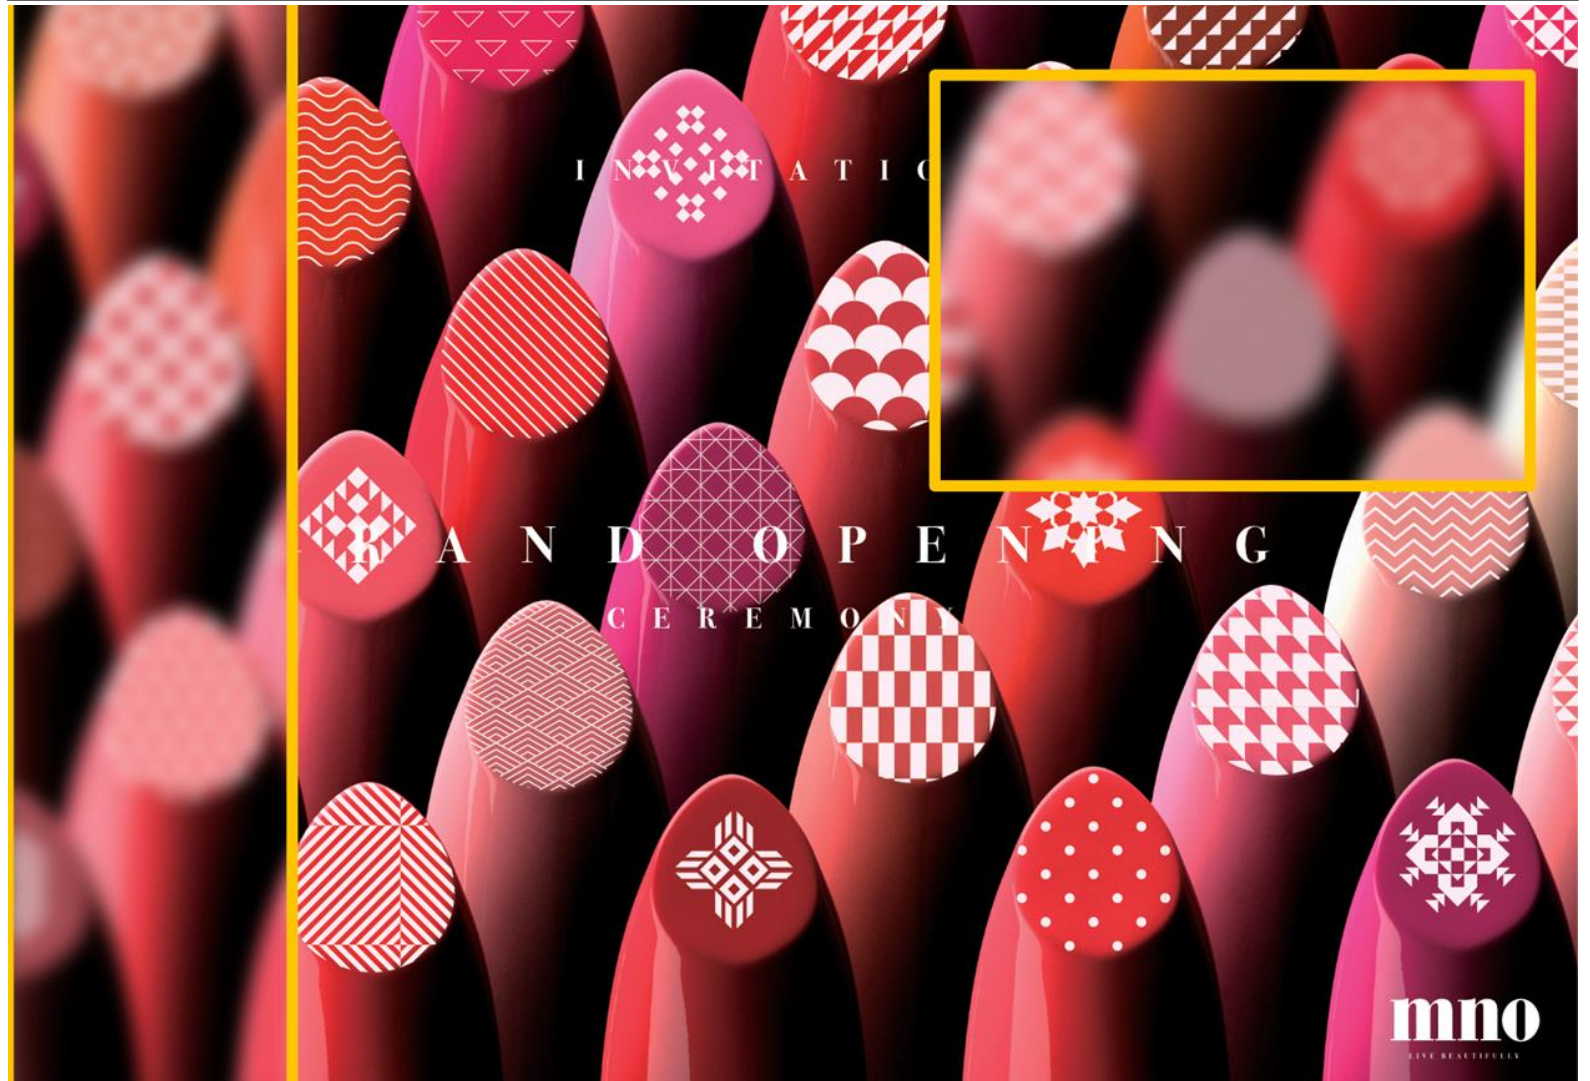
### Causes

- Leveling issues (bed) 4-Corner test.
- Especially if in corner
- Textured media (unevenly)- e.g. 5-10 mm diff in protrusions
- Bowed or uneven media (If measured at high point)
  - EG: Paneled door
- Uneven suction

### Effect: Blurry Sections (not affecting the whole image)

### Solutions

- Level bed
- Flatten or replace media
- Increase suction of vacuum bed/ensure suction is on.
- Cover all vacuum active holes to increase overall suction.

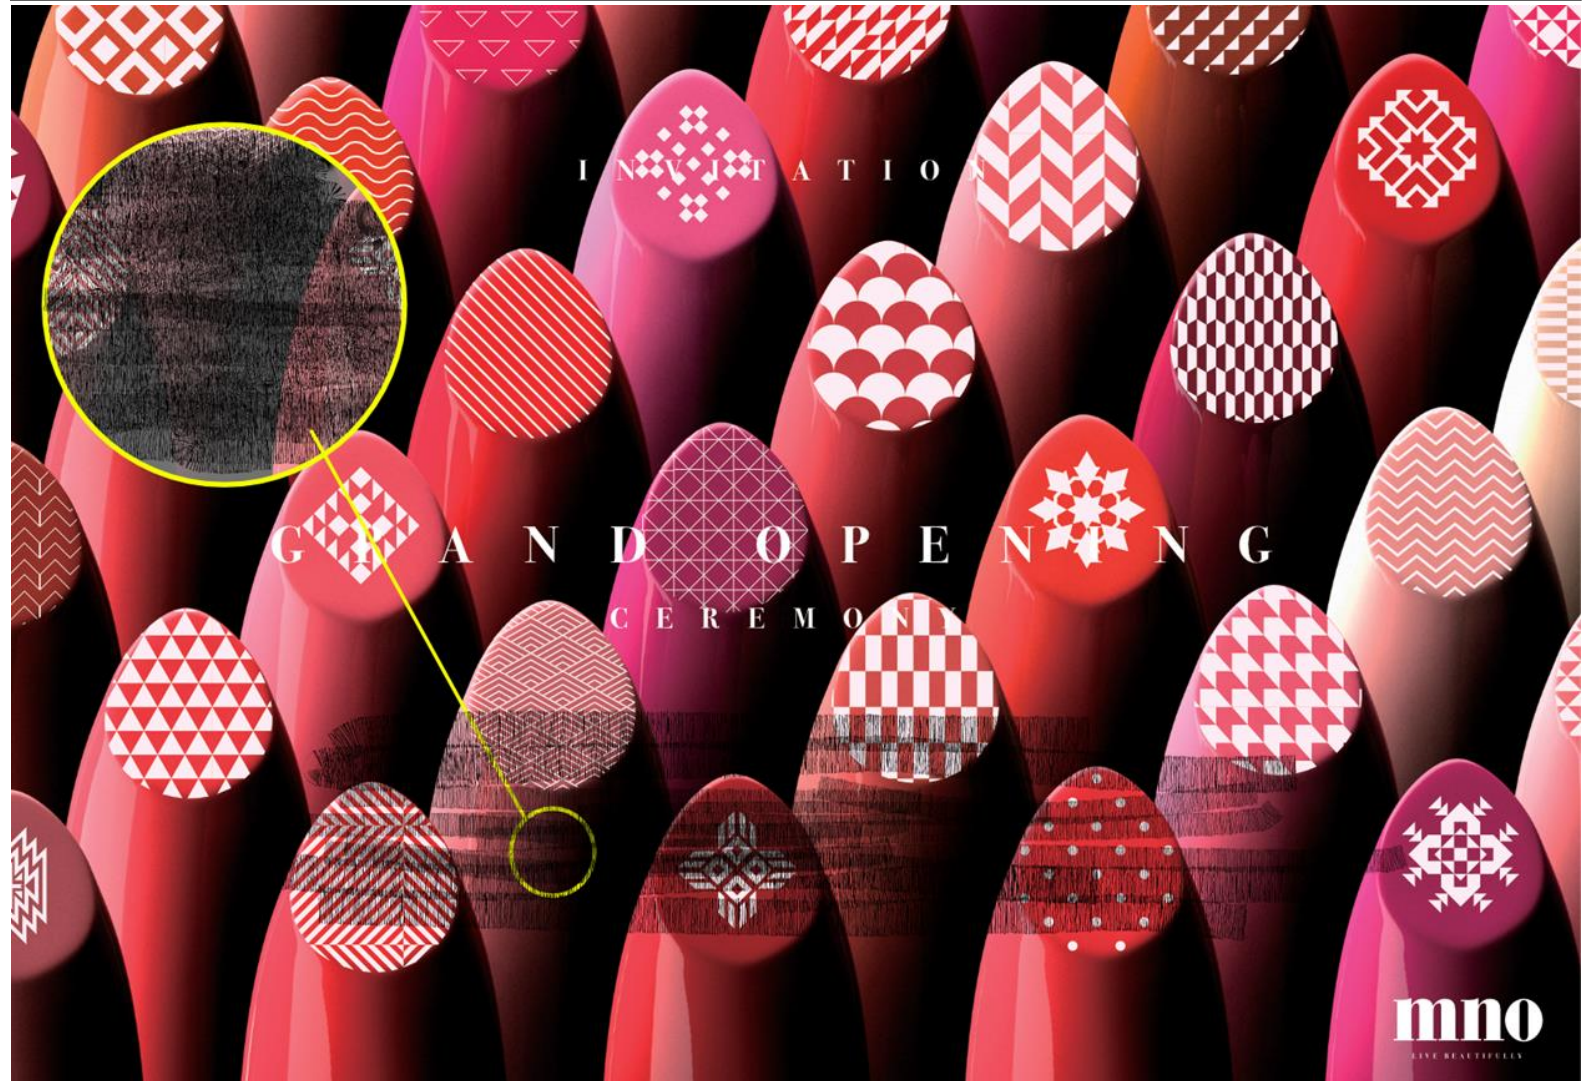
### Causes

- Head too low
- Bowed uneven media. Run 4 corner media height test.
- Bed leveling (quadrant too high) – two tenths of a mm
- Measure at low point of media or uneven bed
- Heat from curing could bow certain media/plastics (1/4-inch acrylic)-make sure to cover all active holes in vacuum section that are not covered. (This is Important)

### Effect: Head strikes media causing print imperfections

### Solutions

- Increase suction (ensure vacuum quadrant open/closed properly)
- Remeasure media/Set head height
  - Raise head
- Level bed

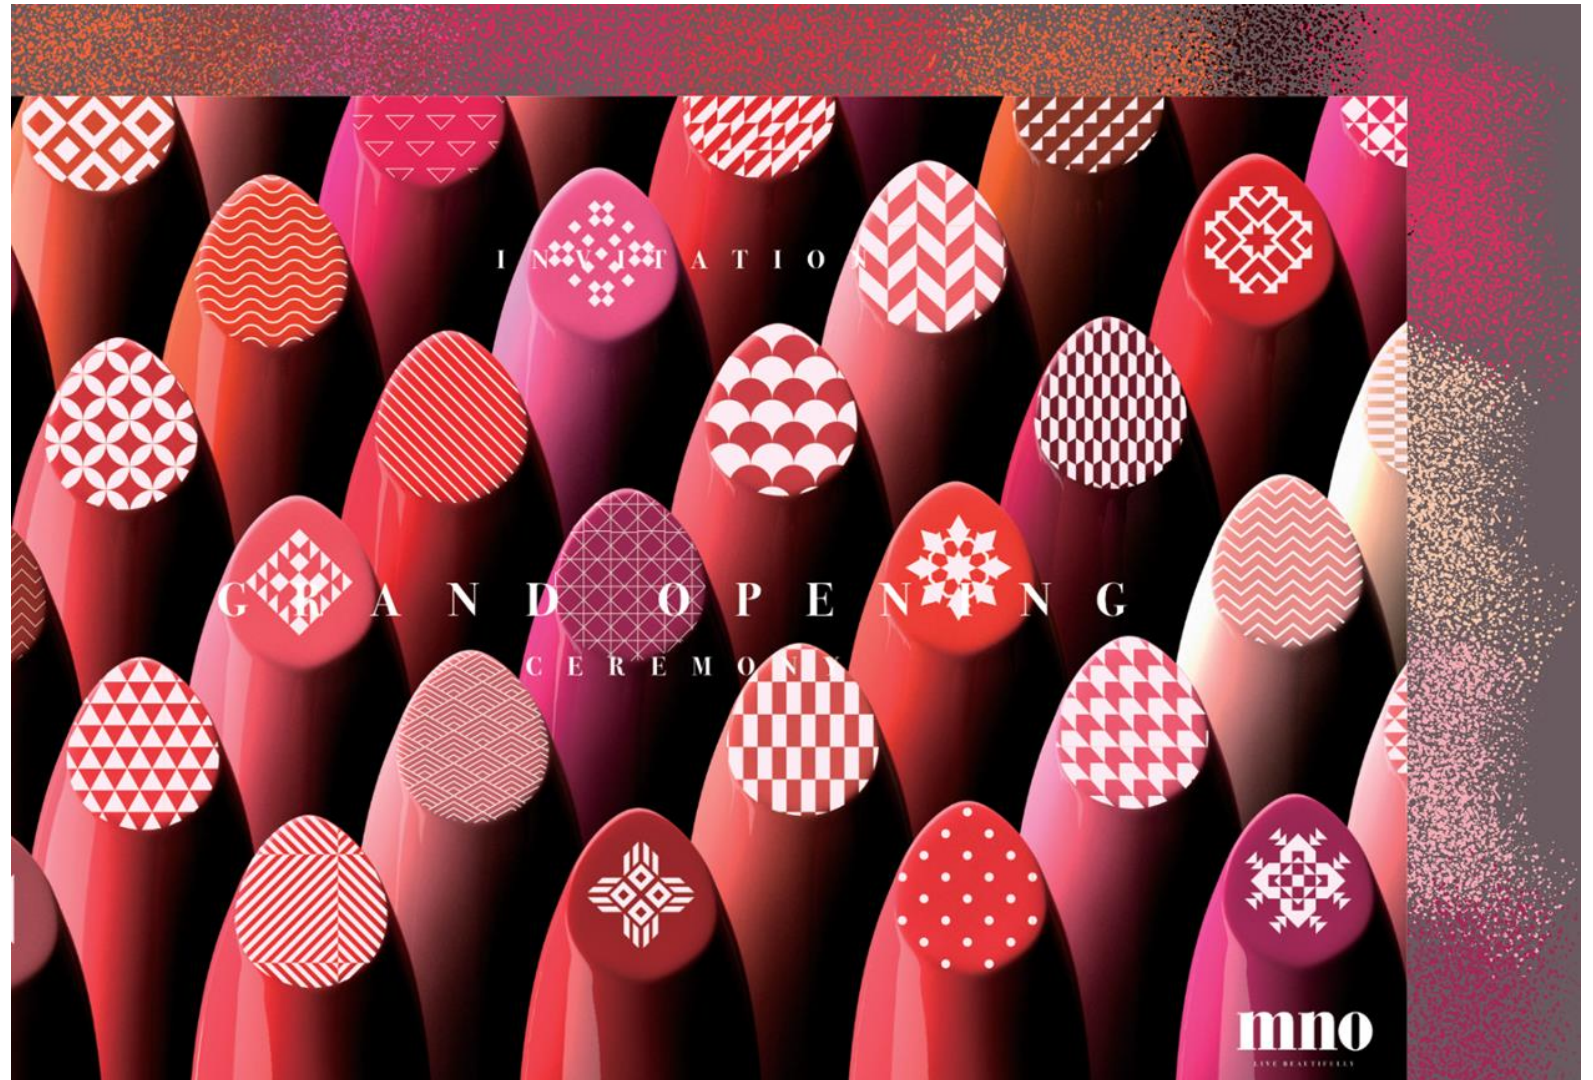
## Causes

- Head is set too high
- Rip/controller settings (incorrect measurements input)
- Environment
  - Lack of humidity
  - Static
- Hardware X/Y Coordinates unaligned

## Effect: Spray extends beyond intended print target

## Solutions

- Verify media height and set manually.
- Adjust head height
- Correct coordinates/controller settings
- Introduce controls for environmental variables such as increasing humidity in dry area. Using anti static devices to remove static.
- Verify Adjustments color and same color.

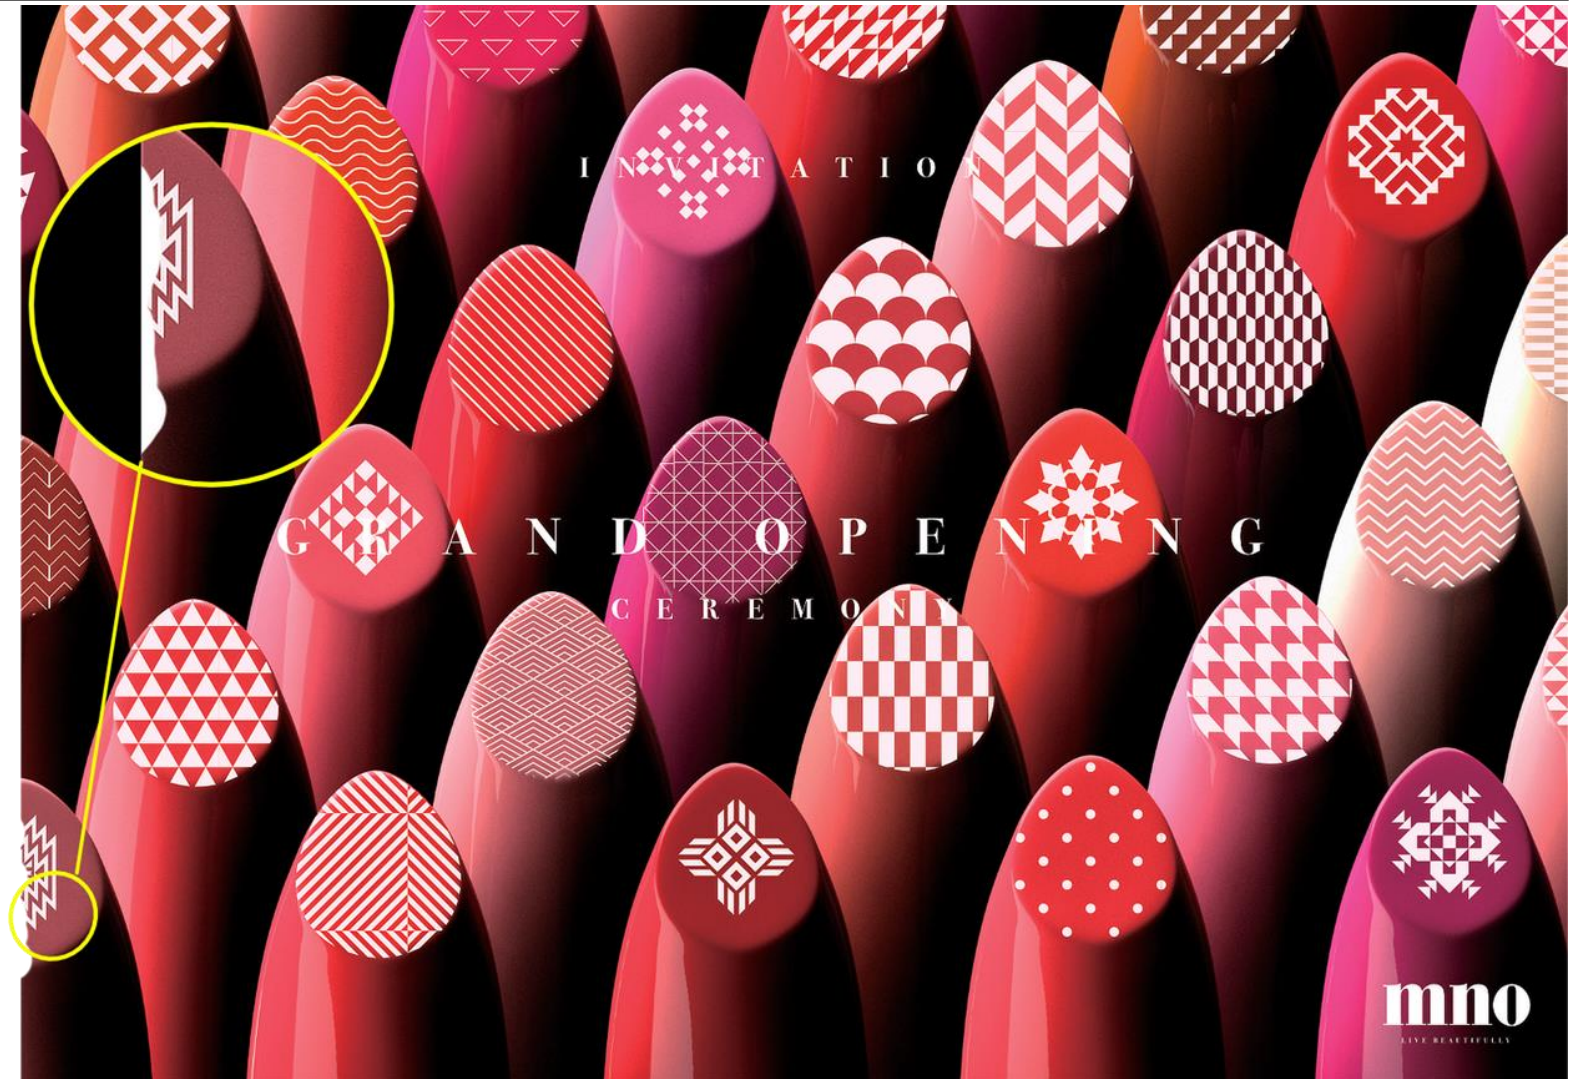
### Causes

- Poor Cutter/Media Combo or dull blade
- Ink Density too high / tactile prints (building raised texture layers) at cut points.
- Media may have poor adhesion or if aged coating may have reduced efficacy
- UV Curing may be too high.
- Darker colors will cure quicker and lowering the UV Light intensity can resolve this.

### Effect: When media is cut, chipping occurs along cut line

### Solutions

- Try a different cutter type or replace blade
  - Note: Cut media prior to see if media chips without ink
- Reduce layers
- Varnish chips faster than regular colors
- Use an adhesion promoter, newer media or a better media
- Decrease UV light intensity on Chiller.

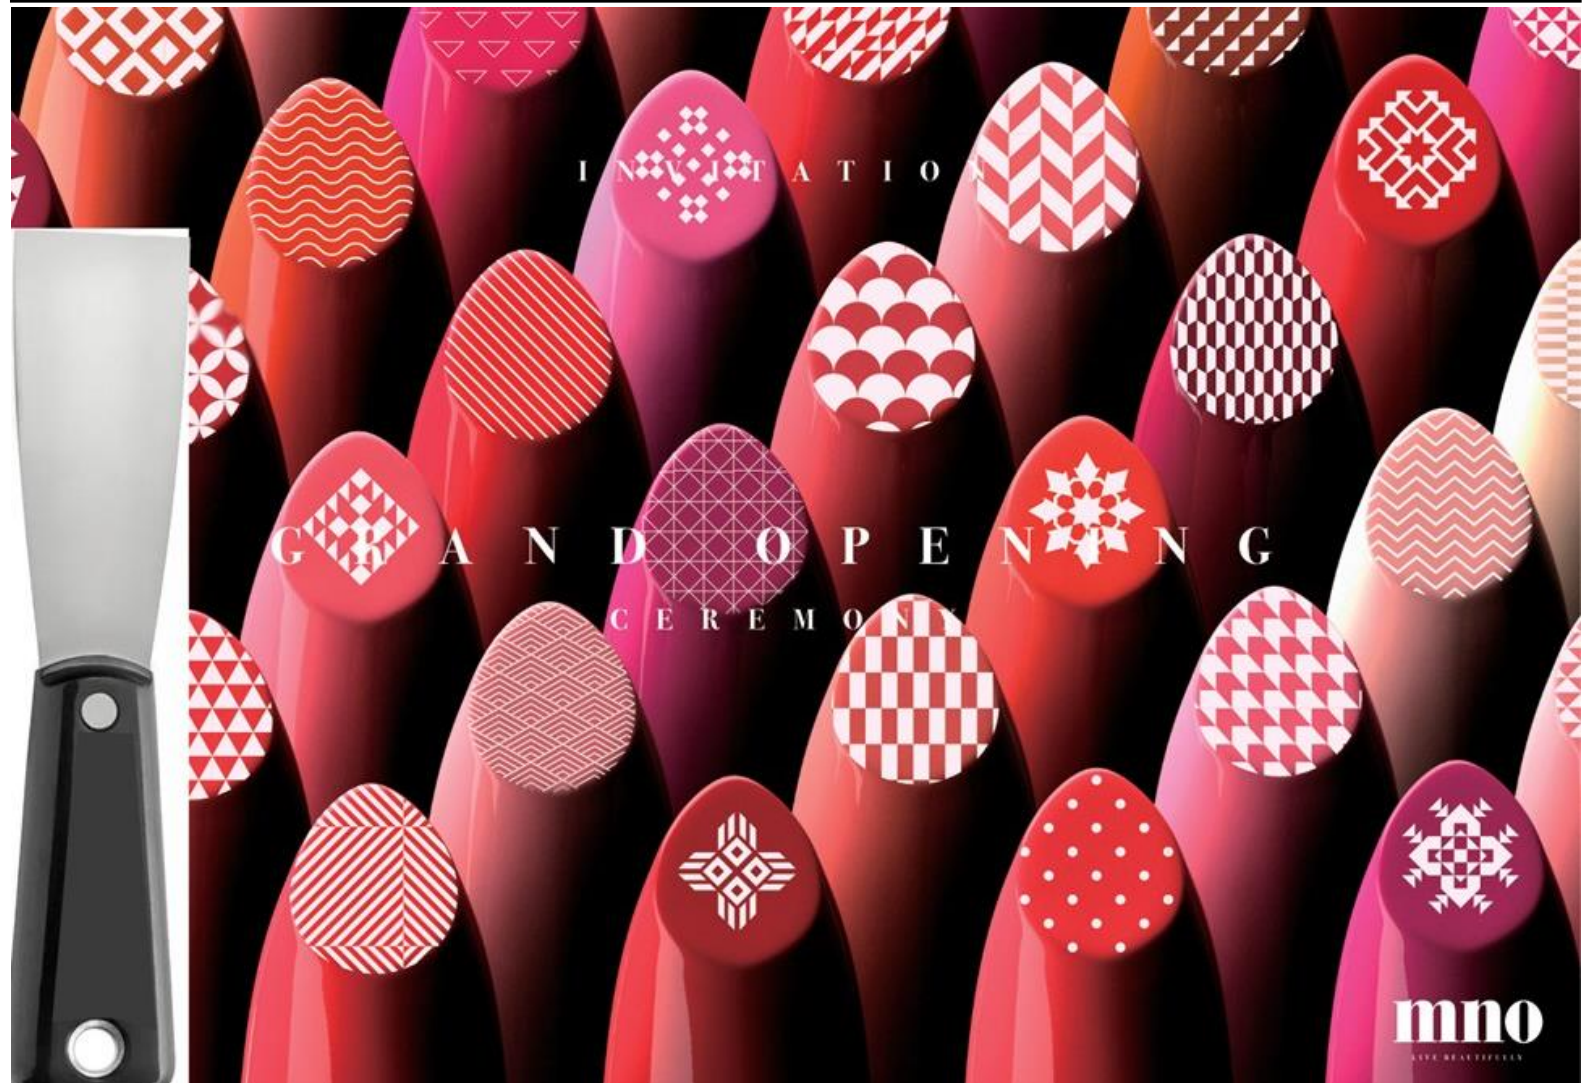
### Causes

- Old Media or Media in Poor Storage Conditions
  - EG: Old corrugated plastic over time micropores from mechanical adhesion process can close or fill up
- Corona treatment expired
- Dirty media/not cleaning or prepping media
- Surface oil on some PVC
- Low surface tension or energy.

### Effect: Ink easily scratches or rubs off media

### Solutions

- Clean media of dust, dirt, oil, etc.
- Use an adhesion promoter or pretreat
- Acrylic, aluminum, and plastic may benefit from corona treatment.
  - Plexiglass: Digital print media will have better tension post treatment
  - Aluminum: Use digital aluminum or prime aluminum with adhesion promoter.

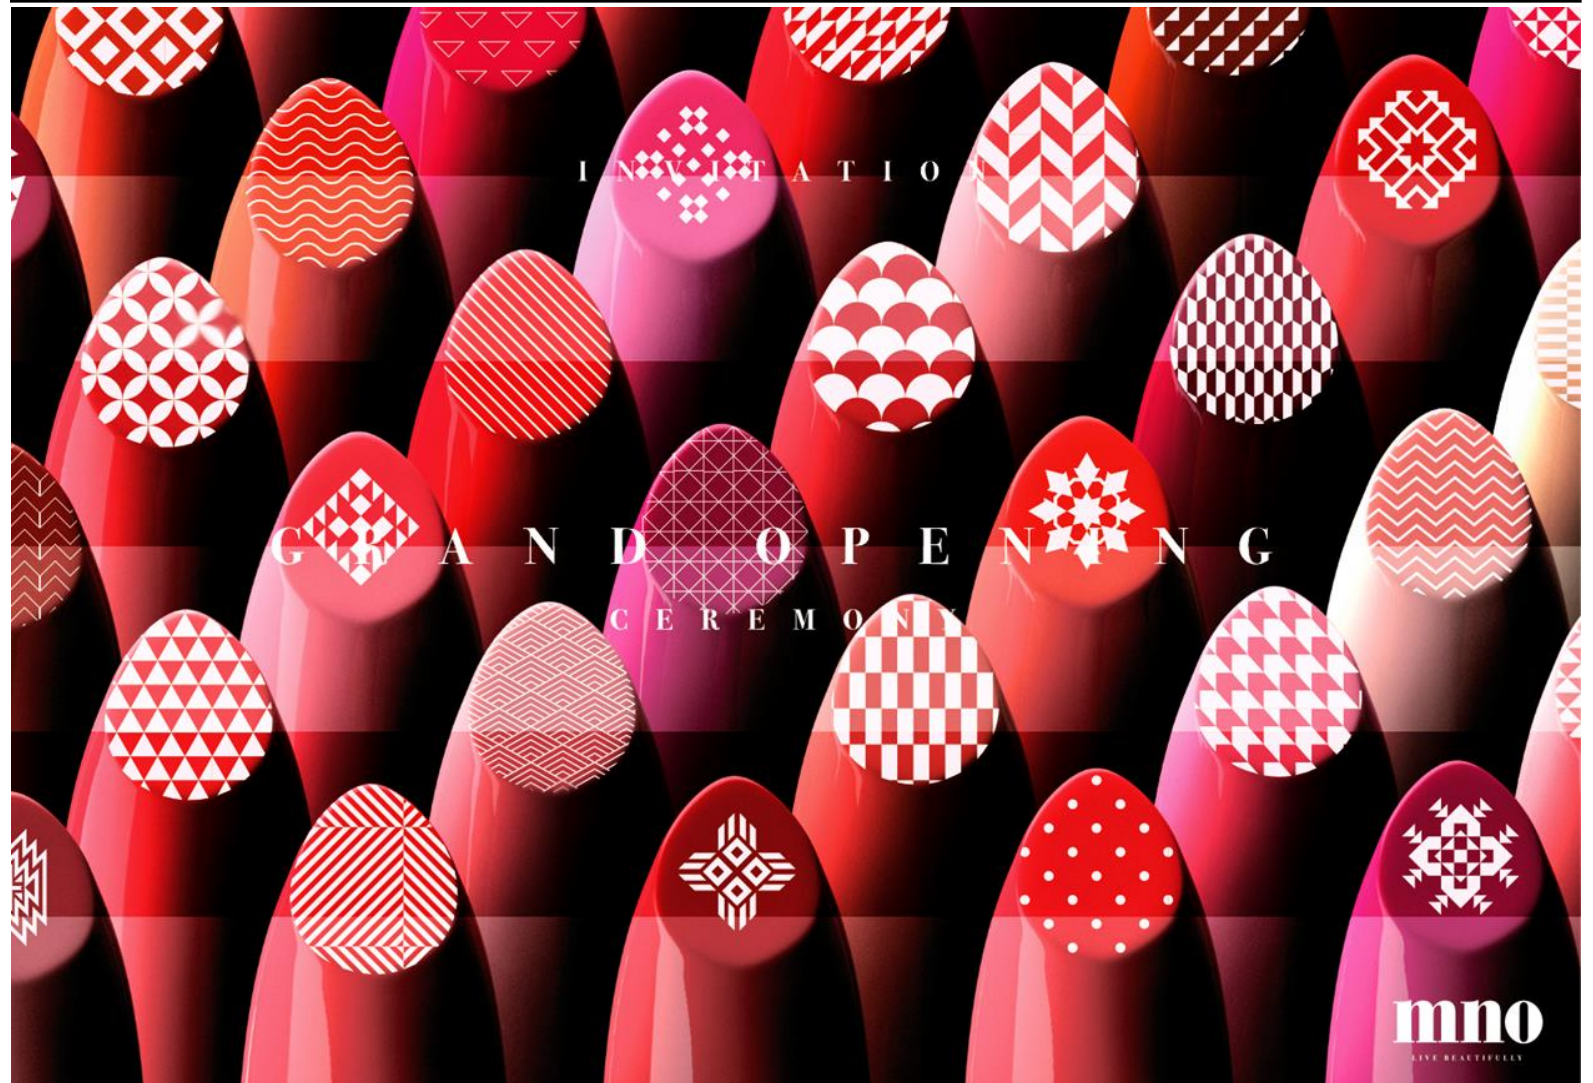
### Causes

- Media type/quality
- Head not aligned
- Printing out of spec

### Effect: Banding that presents as a “lawnmower” effect

### Solutions

- Increase white layer and adhesion
- Use better media
- Ensure alignments are proper (step adjustment)
- Ensure printing is within spec
- Print light white or varnish layer under image to change surface.

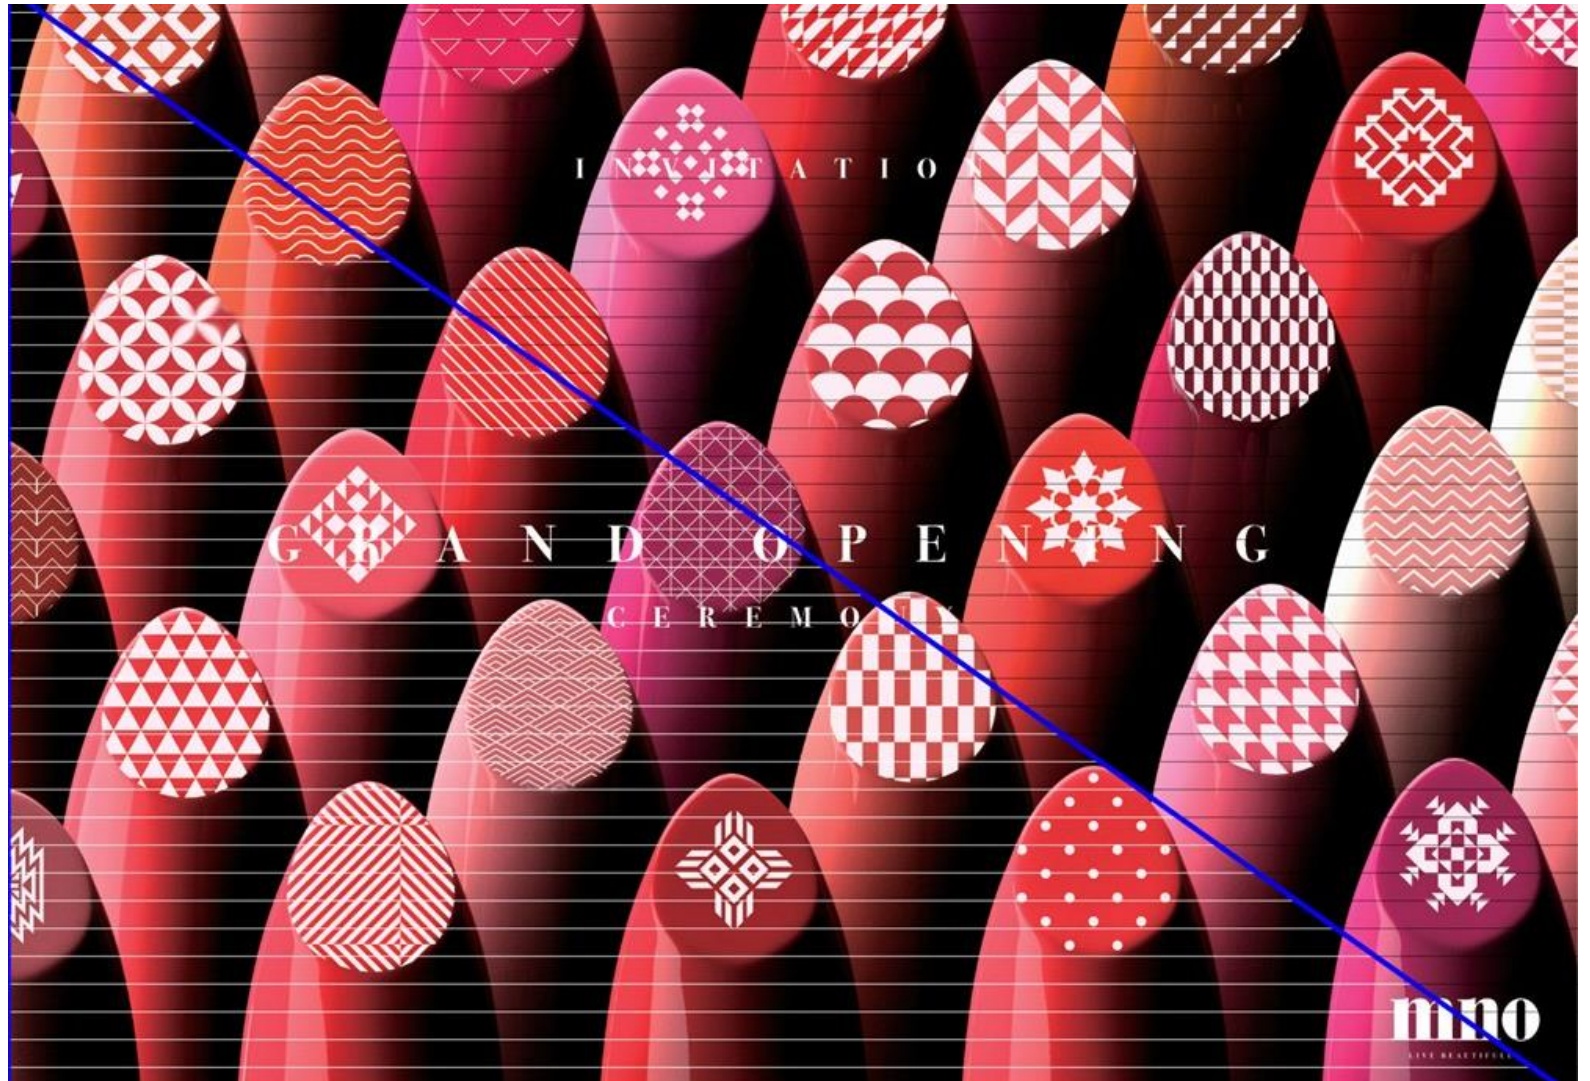
### Causes

- White Gap is typically caused by a missing nozzle (Image Left Side)
- Dark Overlay is usually caused by the ink overlaying due to media feeding too slow or the head not being aligned (Image Right Side). Head Vertical adjustment for SC-V7000.

### Effect: Banding that presents as a white or dark line

### Solutions

- Perform a head cleaning/Nozzle check
- Perform a head alignment (On flatbeds media feed does not apply).
- Perform Head Vertical adjustment for dark overlap or white overlap if all nozzles are present on the SC-V7000

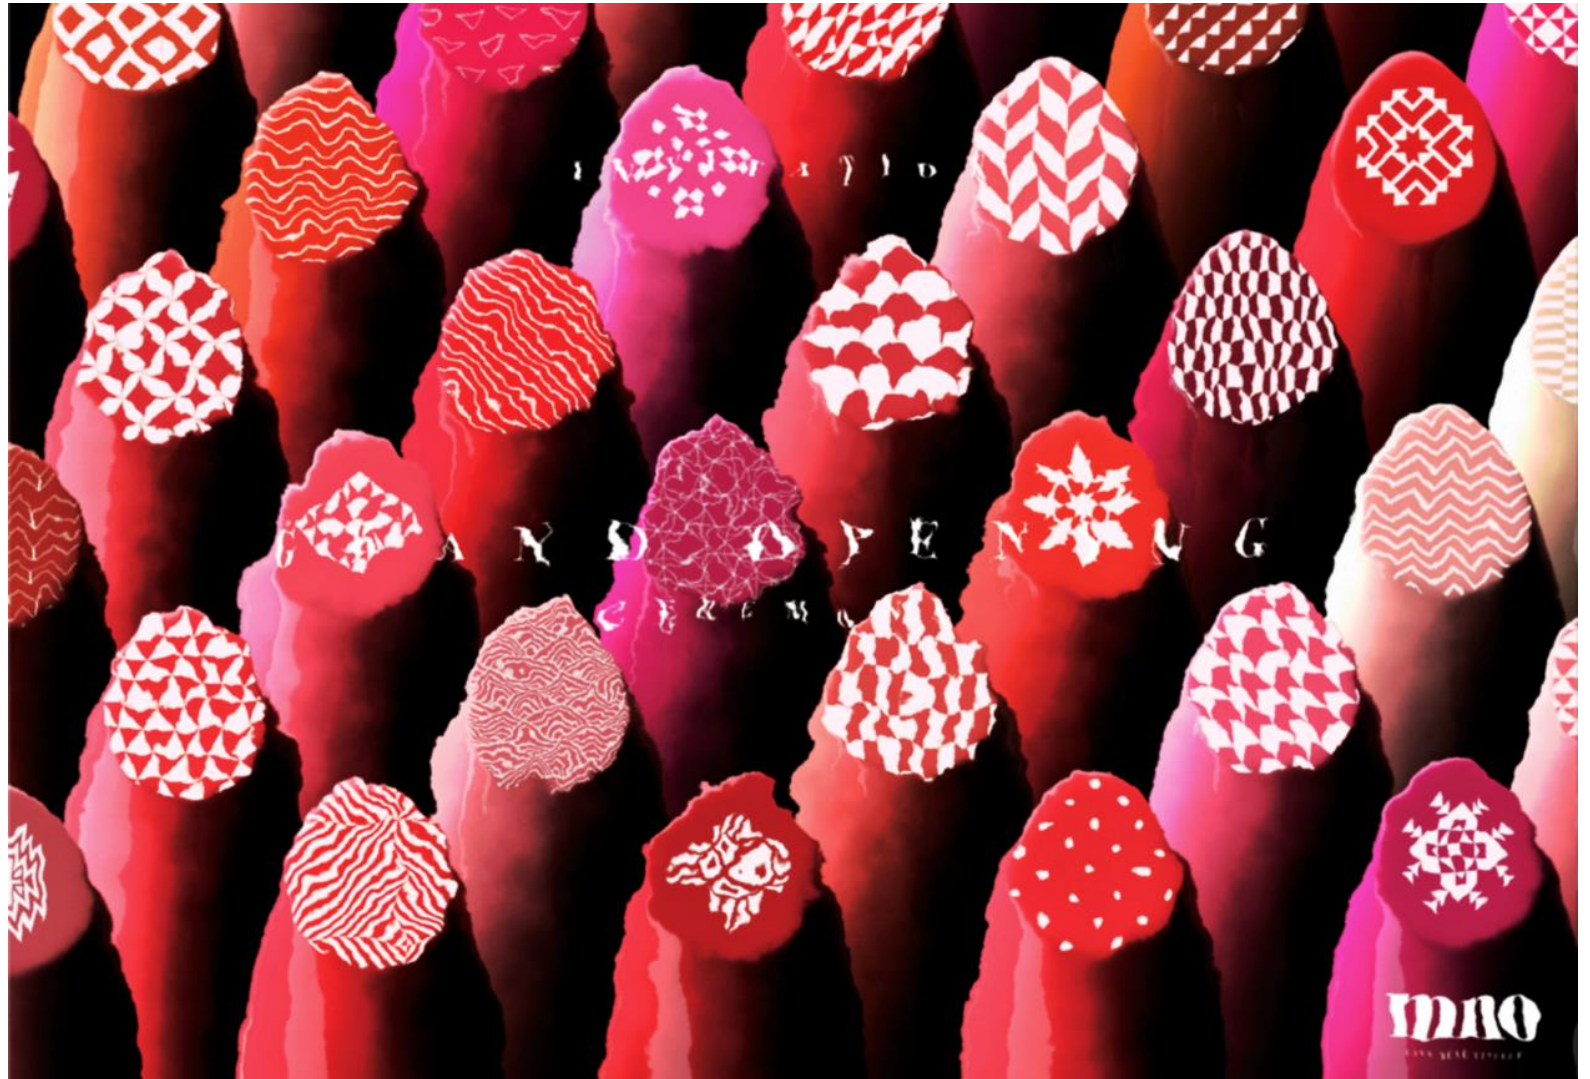
## Wet (Not Cured)

### Causes

- Curing is not being performed effectively
- Chiller error (E3-E1-E2)
- Low Coolant (E3) Error
- Cold Coolant low flow (E3) Error
- Lamp issues

### Effect: Ink is wet

### Solutions

- If “wet” effect appears minor, turning on after cure mode may solve the issue. Slight tacky ink may be possible first day of installation.
- Call support for chiller or lamp issues
  - Chiller: Check for chiller screen error
  - No Chiller Error: Lamp adjustment or maintenance may be needed.

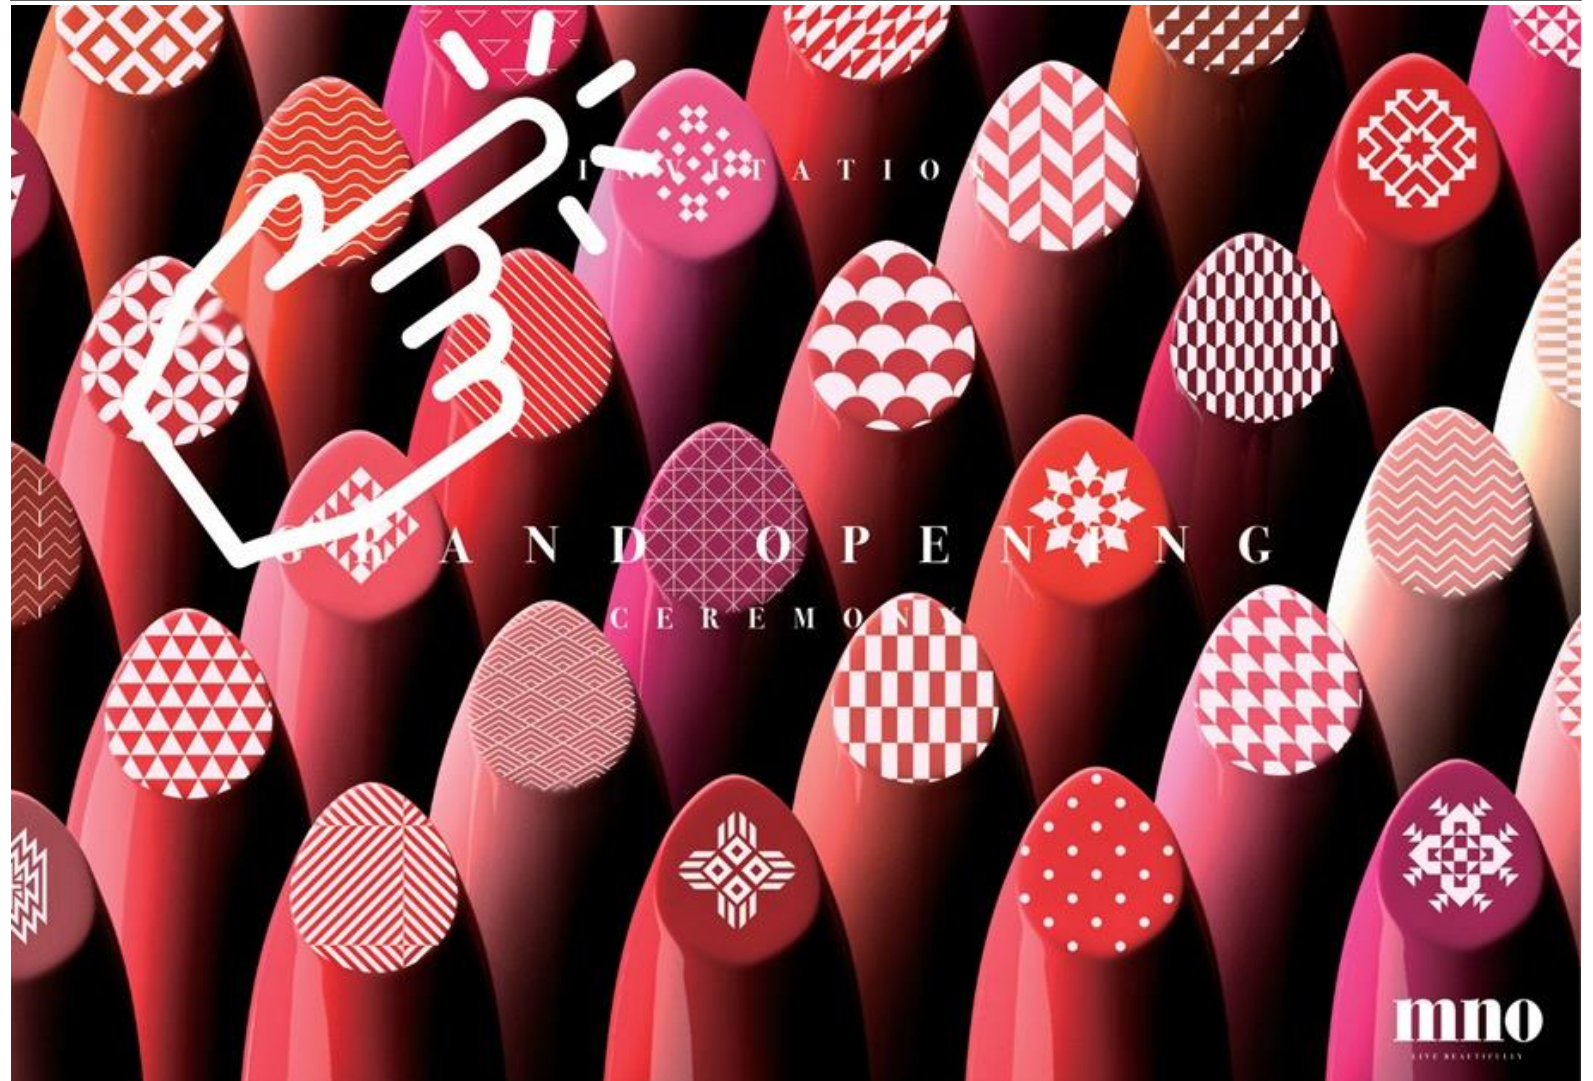
### Causes

- Dirty curing lamps
- Chiller or lamp issues
- After an install or service event the first few prints may have cleaning fluid and appear sticky as a result.

### Effect: Print job feels very sticky to touch

### Solutions

- Clean the UV lamps if needed
- Turn on after cure mode may solve the issue.
- Call support for chiller or lamp issues
  - Chiller: Check for chiller screen error
  - No Chiller Error: lamp adjustment or maintenance may be needed
- Time will typically allow for the ink to solidify and reduce the “sticky” feeling on touch
- Verify percentage of UV intensity on the Chiller. Change the percentage of power may help.

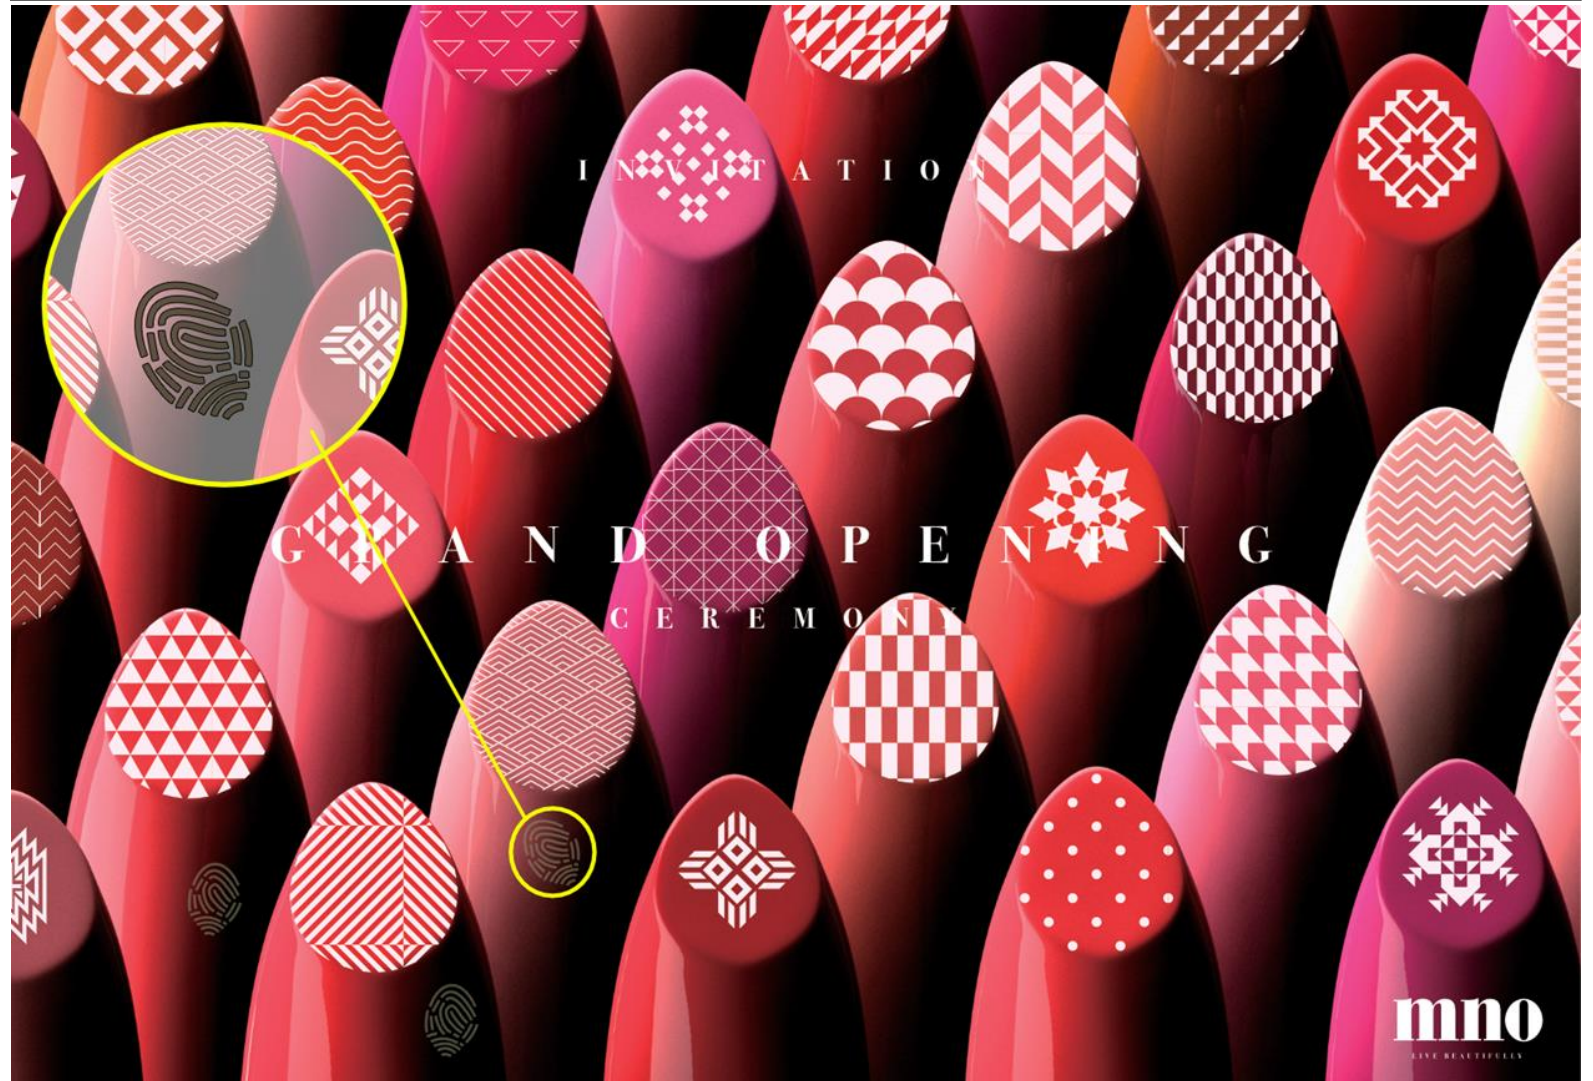
### Causes

- Unclean media/dirty hands touch media leaving finger prints behind
- Human oil/grease from fingers onto media could cause issues
- Note: Most commonly this can be observed from the rear of a clear substrate like acrylic but can also show on the front side of prints

### Effect: Finger Prints appear on print job

### Solutions

- Clean hands or handle media with gloves, especially media prone to finger prints showing through
- Clean media before printing/if handled by dirty hands
