# Print Quality Trouble Shooting Guide

## V-Series

Version 1.0

Date: 2/18/2025

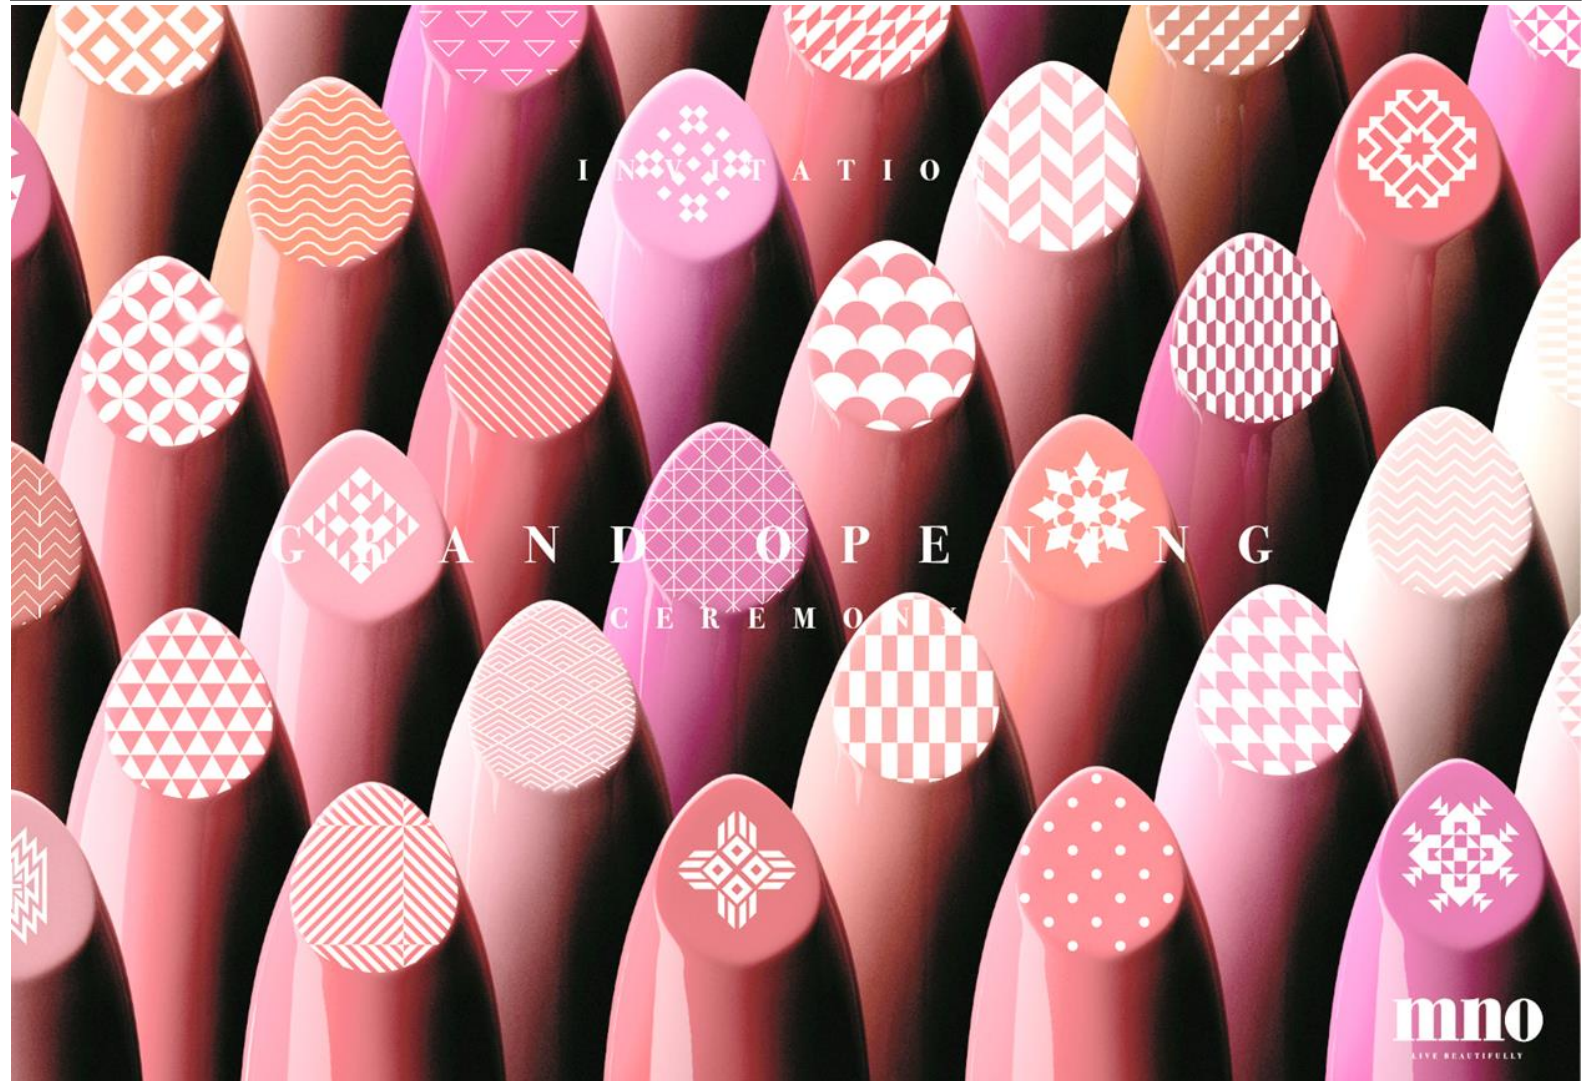
### Causes

- Wrong quality selection
- Missing nozzles
- Bad color management or job build issues
- Corrupt file
- Media too absorbent
- Wrong profile being used
- Non-standard/unoptimized rips

### Effect: Color appears washed or incorrect

### Solutions

- Ensure you are using the correct profiles for your printer and when building your jobs
- Lay down extra white layers on porous or poor performing media
- Use a different media
- Perform a head cleaning/nozzle check
- Use the included RIP to help rule out software issues
- Change Print Quality setting to a higher setting. Increase color density.

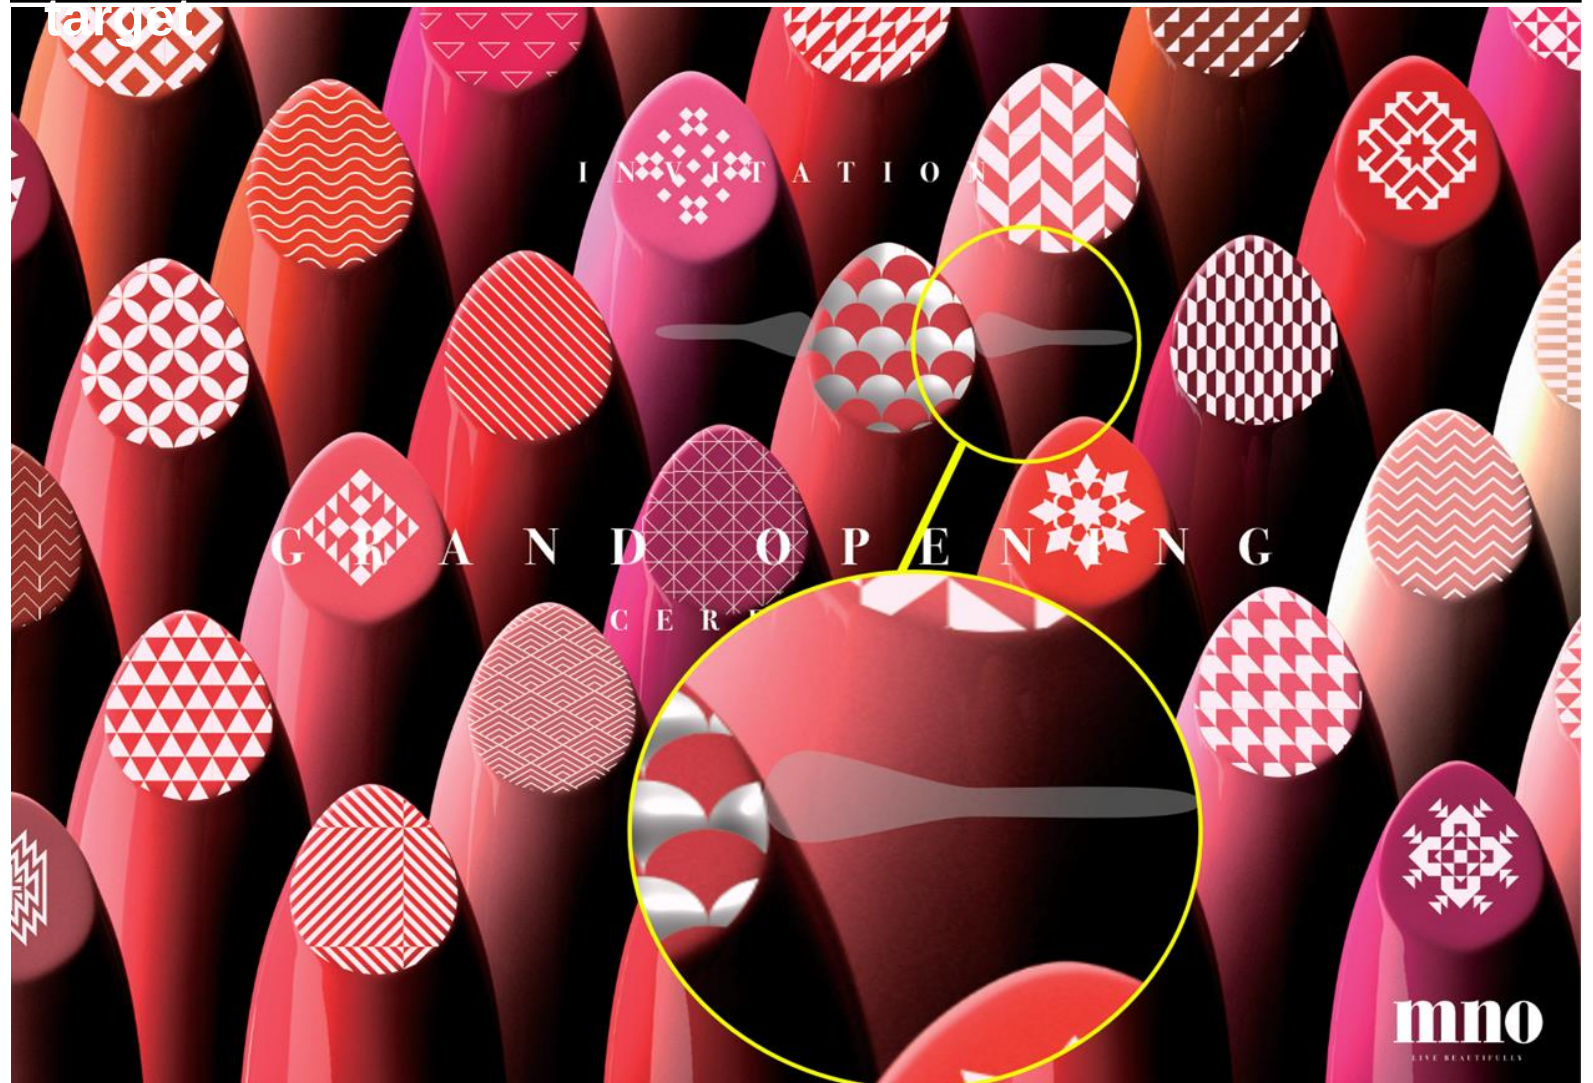
### Causes

- Too much ink density may cause varnish or ink to spread past the target.
- Too many ink layers may cause white or Varnish to spread.

### Effect: Tactile print spreads or overspray's past intended

### Solutions

- Adjust the head height between passes or send the job in stages to allow for the print head to be adjusted for the additional height
- Use less layers/find the maximum number of layers for your application.
- Decrease amount or density of Varnish. Recommend to start at 65% Varnish and increase as needed.

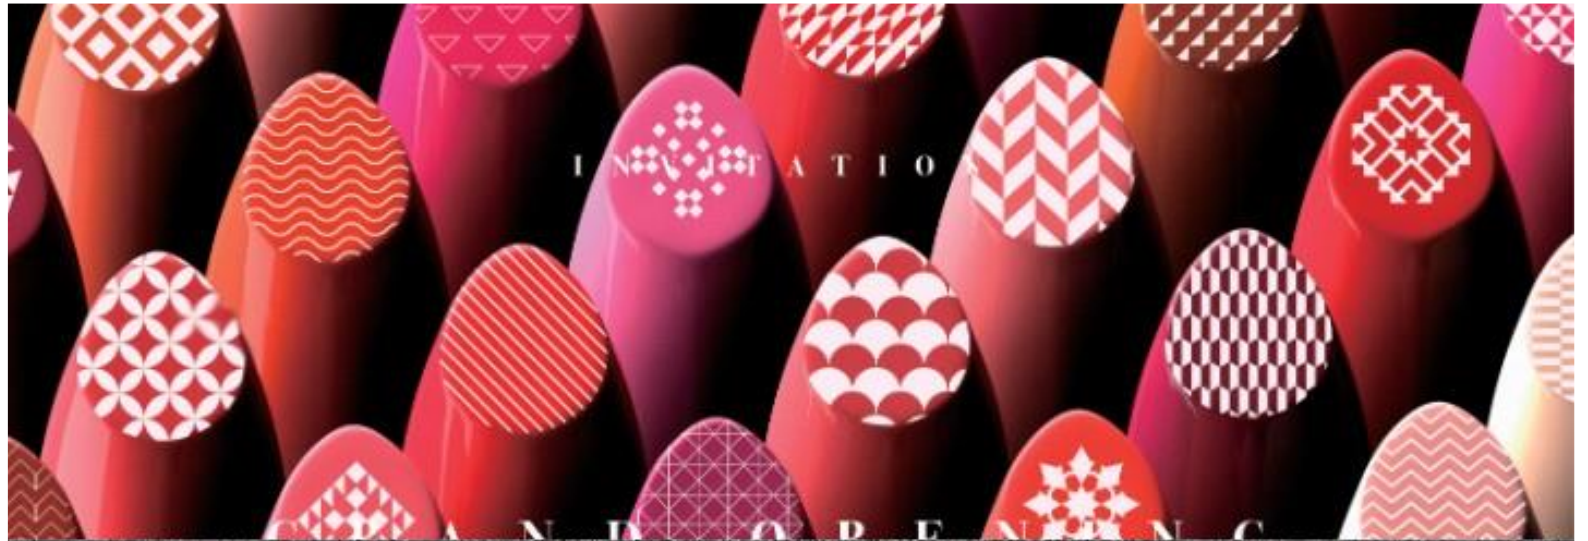
### Causes

- Issue could be caused by network or security settings
- Could be an issue with your RIP
- Possible corrupted file during network transfer.

### Effect: Job does complete (Partial Print)

### Solutions

- Check with RIP developer for documentation/help
- Ensure needed Firewall Ports are open
- Double check network settings confirm with your organization and general best practices
- Ensure Windows has allowed application to receive data from network. No firewall.
- Bad network/USB cable, router or switch.

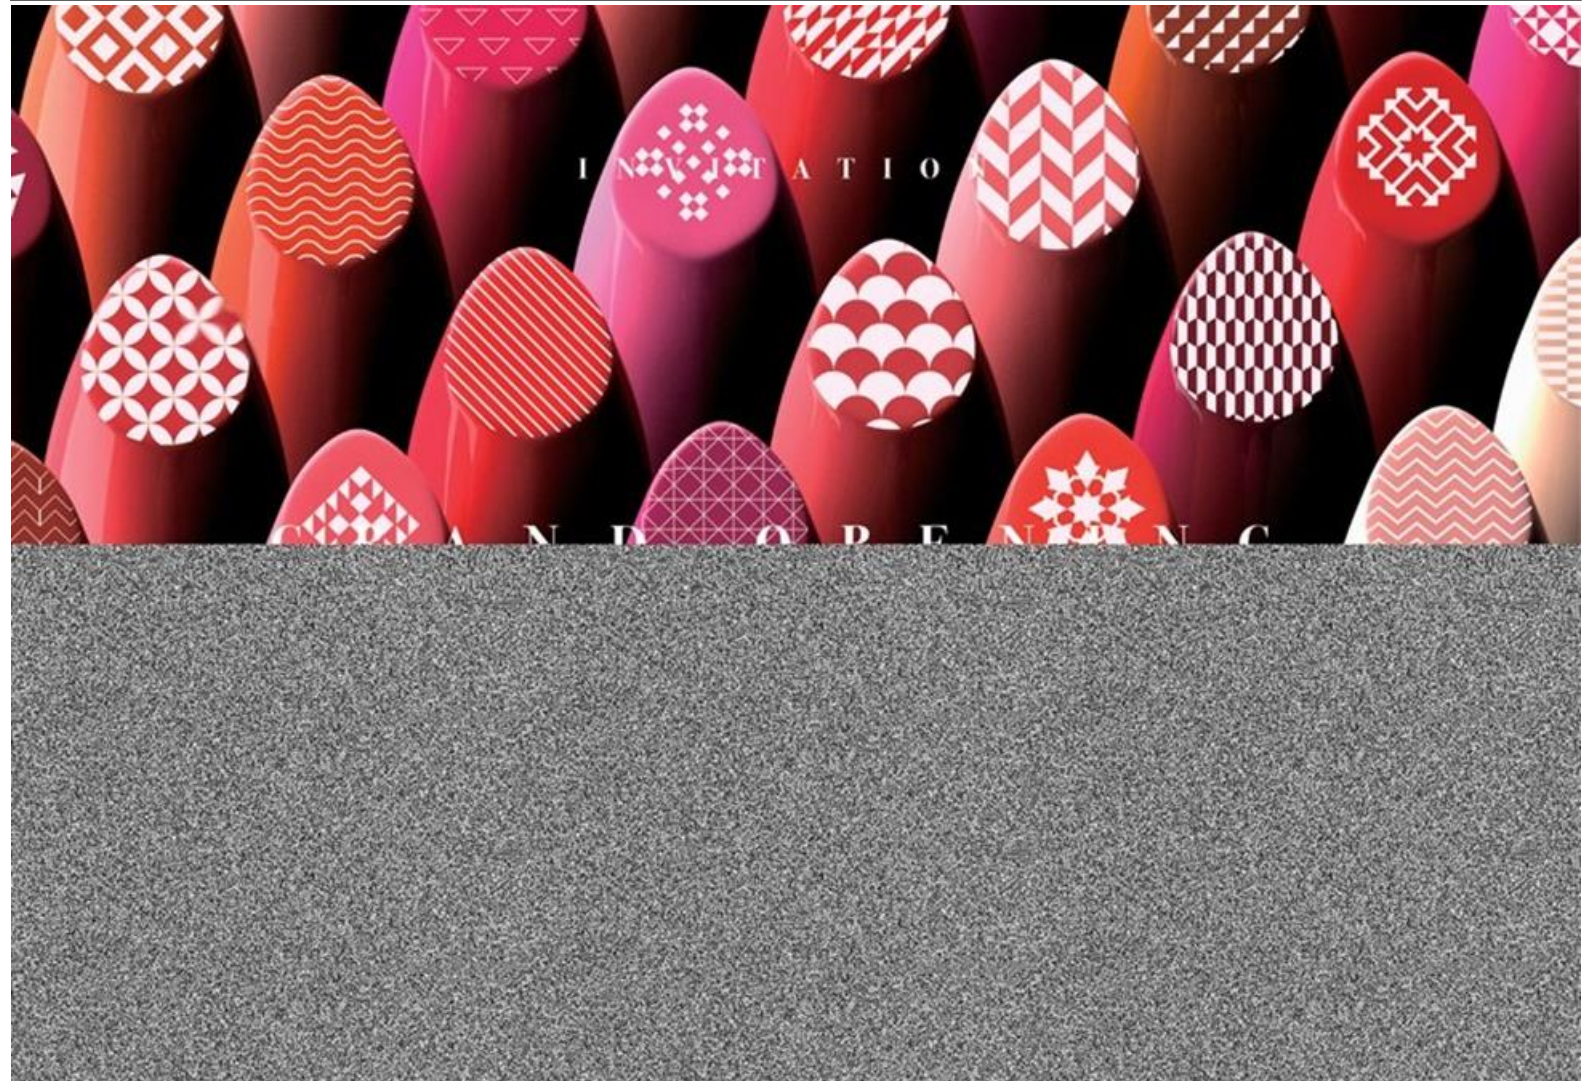
### Causes

- Corrupt File
- Data transfer Issue

**Effect: Portion of print does not print correctly, presents as static**

### Solutions

- Try again
- Reproduce export file
- Verify network integrity.
- Verify cables and connections.
