# Print Quality Trouble Shooting Guide

## V-Series

Version 1.0

Date: 2/18/2025

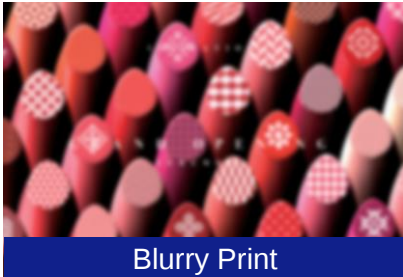
Blurry Print

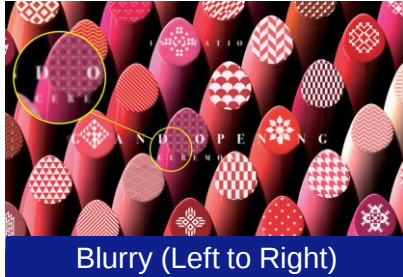
Blurry (Left to Right)

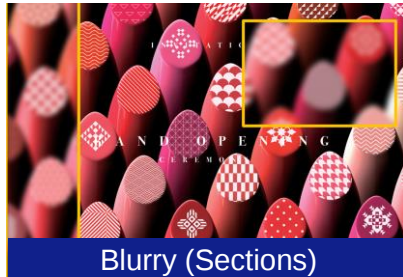
Blurry (Sections)

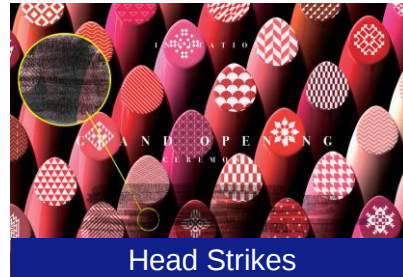
Head Strikes

- Level bed
- Flatten or replace media
- Increase suction of vacuum bed/ensure suction is on.
- Cover all vacuum active holes to increase overall suction.

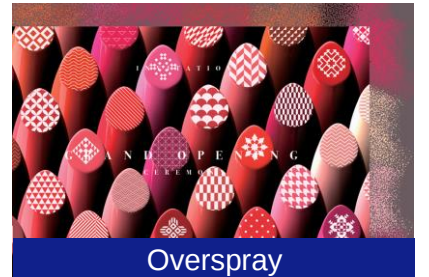
Overspray

- Head is set too high
- Rip/controller settings (incorrect measurements input)
- Environment
  - Lack of humidity
  - Static
- Hardware X/Y Coordinates unaligned

- Verify media height and set manually.
- Adjust head height
- Correct coordinates/controller settings
- Introduce controls for environmental variables such as increasing humidity in dry area. Using anti static devices to remove static.
- Verify Adjustments color and same color.

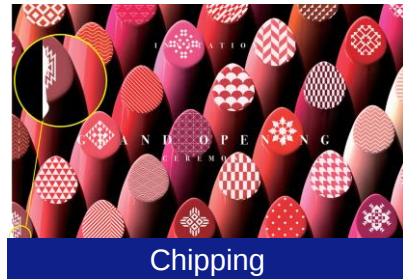
Chipping

- Try a different cutter type or replace blade
  - Note: Cut media prior to see if media chips without ink
- Reduce layers
- Varnish chips faster than regular colors
- Use an adhesion promoter, newer media or a better media
- Decrease UV light intensity on Chiller.

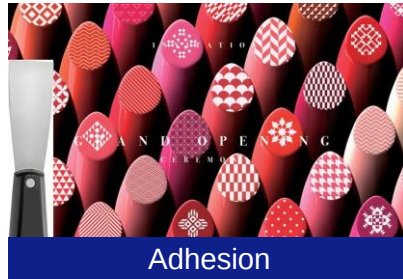
Adhesion

- Old Media or Media in Poor Storage Conditions
  - EG: Old corrugated plastic over time micropores from mechanical adhesion process can close or fill up
- Corona treatment expired
- Dirty media/not cleaning or prepping media
- Surface oil on some PVC
- Low surface tension or energy.

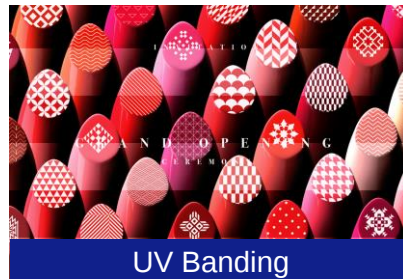
UV Banding

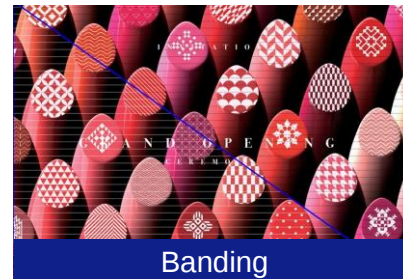
Banding

- White Gap is typically caused by a missing nozzle (Image Left Side)
- Dark Overlay is usually caused by the ink overlaying due to media feeding too slow or the head not being aligned (Image Right Side). Head Vertical adjustment for SC-V7000.

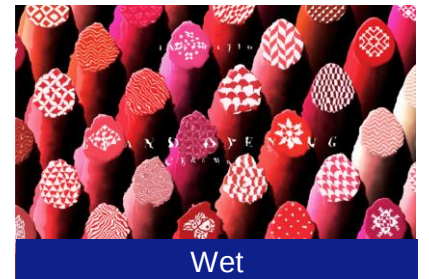
Wet

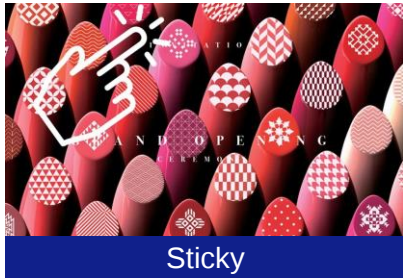
Sticky

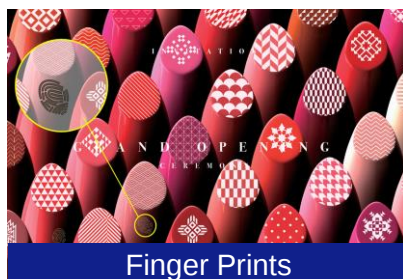
Finger Prints

- Unclean media/dirty hands touch media leaving finger prints behind
- Human oil/grease from fingers onto media could cause issues
- Note: Most commonly this can be observed from the rear of a clear substrate like acrylic but can also show on the front side of prints

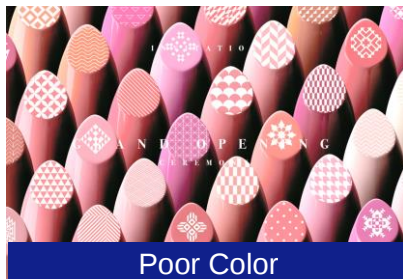
Poor Color

- Wrong quality selection
- Missing nozzles
- Bad color management or job build issues
- Corrupt file
- Media too absorbent
- Wrong profile being used
- Non-standard/unoptimized rips

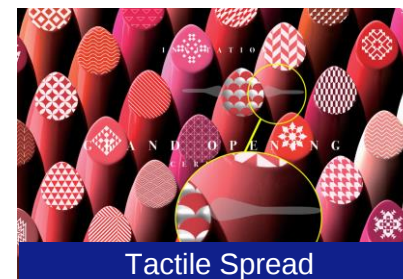
Tactile Spread

- Too much ink density may cause varnish or ink to spread past the target.
- Too many ink layers may cause white or Varnish to spread.

- Adjust the head height between passes or send the job in stages to allow for the print head to be adjusted for the additional height
- Use less layers/find the maximum number of layers for your application.
- Decrease amount or density of Varnish. Recommend to start at 65% Varnish and increase as needed.

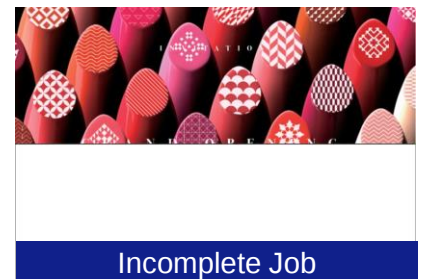
Incomplete Job

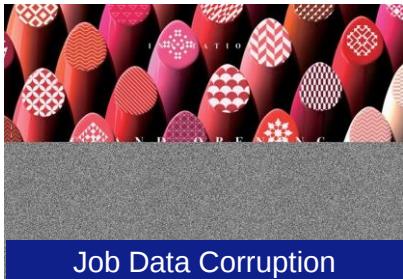
Job Data Corruption

- Issue could be caused by network or security settings
- Could be an issue with your RIP
- Possible corrupted file during network transfer.

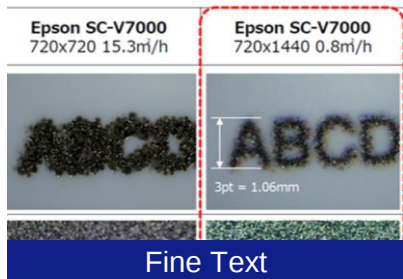
Fine Text
